PARTIAL TEST REPORT IEC 60598-2-3 Luminaires

Part 2: Particular requirements: Section Three – Luminaires for road and street lighting

Report Reference No.
 4786324191.1.1

Model/Type reference URBAN ARREDO URBANO 150 W E40 SE

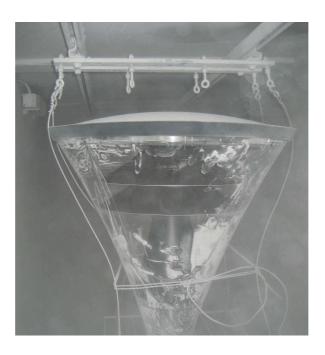
Photograph No. 3 Luminaire into test chamber after IP6X Test.

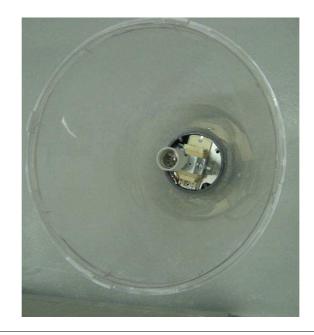
a) no deposit in dust-proof luminaire		N/A
	b) no talcum in dust-tight luminaire	Test IP6X: after test no found the dust inside the luminaire. (see photos ANNEX 1)	Р

Photograph No. 4 Luminaire after IP6X (Pass no dust into luminaire)

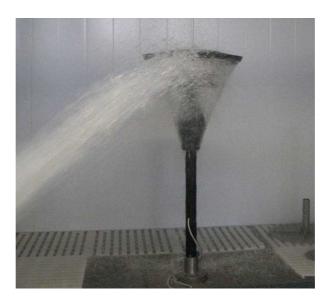
Photograph No. 7 Luminaire during IPX6 Test.

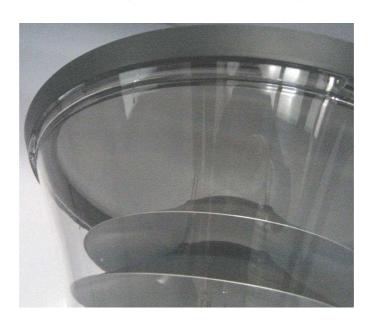
c) no trace of water on current-carrying parts or SELV parts or where it could become a hazard		N/A
	d) i) For luminaires without drain holes – no water entry	Test IPX6: After the test, no found water inside the luminaire. (see photos ANNEX 1)	Р

Photograph No. 9 Luminaire after IPX6 (Pass no water inside luminaire)

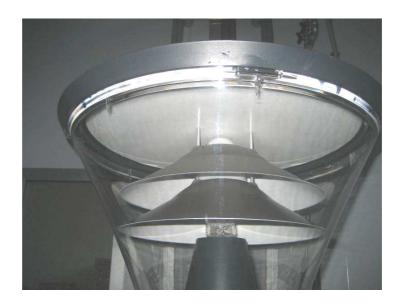
Photograph No. 10 Luminaire after IPX6 (Pass no water inside luminaire)

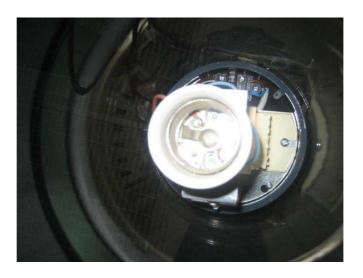
Photograph No. 13 Luminaire after IPX6 (Pass no water inside luminaire)

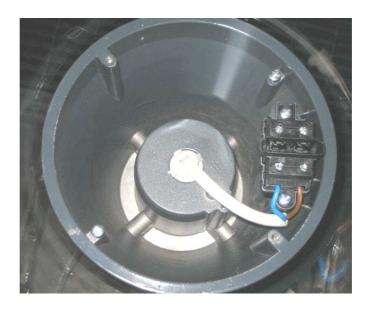
Photograph No. 14 Luminaire after IPX6 (Pass no water inside luminaire)
