PARTIAL TEST REPORT
IEC 60598-2-3
Luminaires
Part 2: Particular requirements:
Section Three – Luminaires for road and street lighting

Report Reference No.: 4786324191.1.2
Date of issue.....: 14 March 2014
Total number of pages 14 including attachments

Test item description: LED Luminaires for road and street lighting
Trade Mark: ACRILUX
Manufacturer: ACRILUX S.P.A.
S.S. 571 Km 10+983 – Recanati – 62019 (MC) - Italy
Model/Type reference: URBAN LED 1050 mA 56 W
Ratings: 230 V 50 Hz; 56 W ; LED module 1050 mA ; IP 66; Class II.

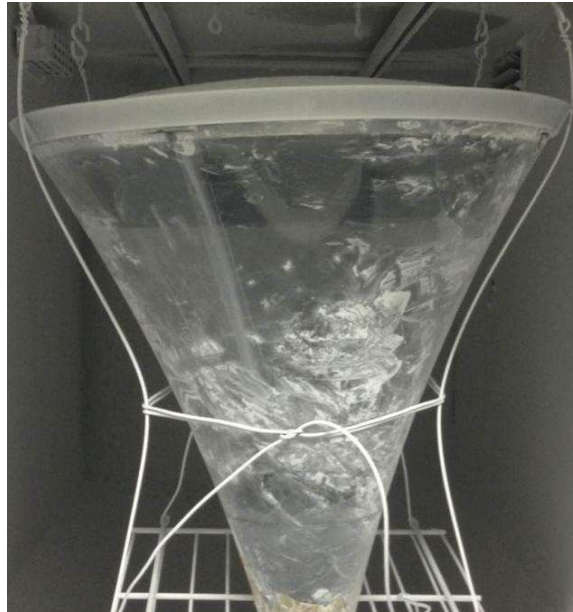
Photograph No. 3 Luminaire into test chamber after IP6X Test.

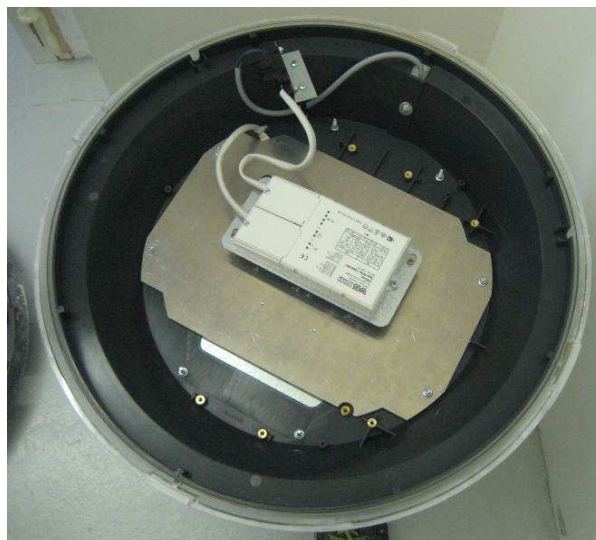
a) no deposit in dust-proof luminaire		N/A
	b) no talcum in dust-tight luminaire	Test IP6X: After the test no found dust inside the luminaire. (see Annex 1)	P

Photograph No. 4 Luminaire after IP6X Test.(Pass no dust into luminaire)

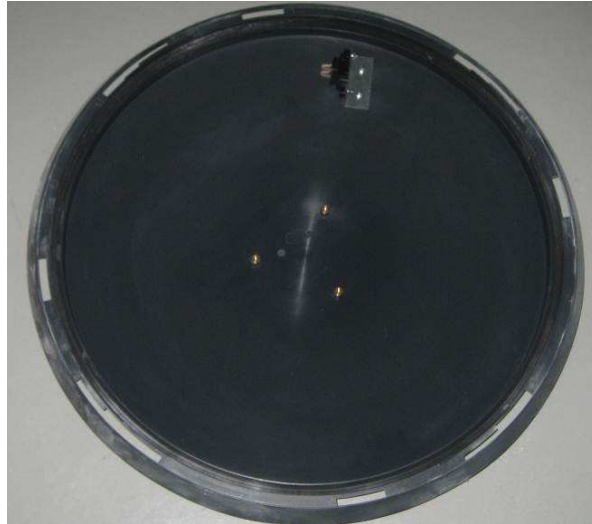
Photograph No. 5 Luminaire after IP6X Test.(Pass no dust into luminaire)

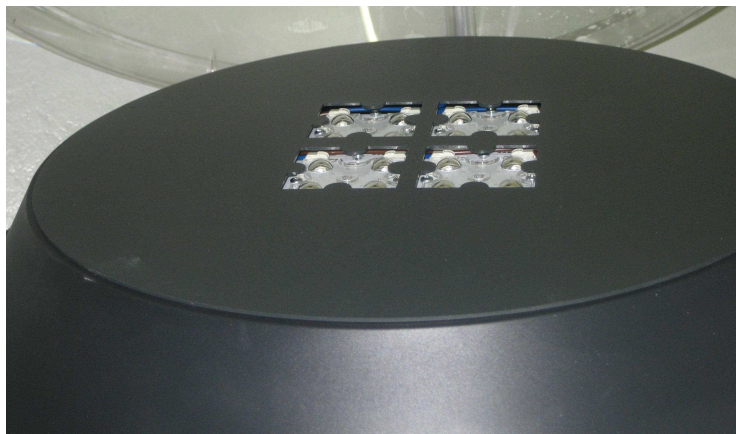
Photograph No. 6 Luminaire after IP6X Test.(Pass no dust into luminaire)

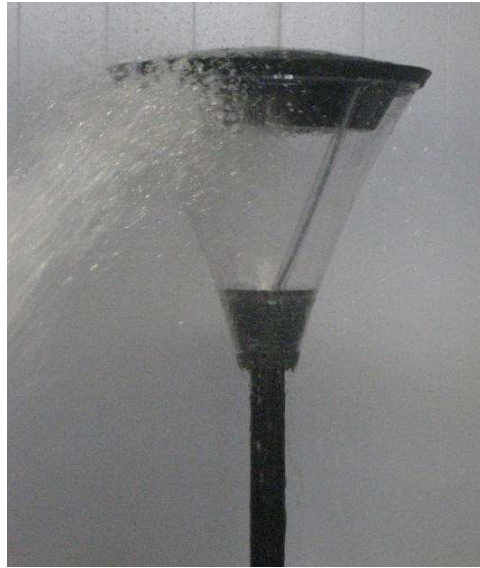
Photograph No. 7 Luminaire during IPX6 test

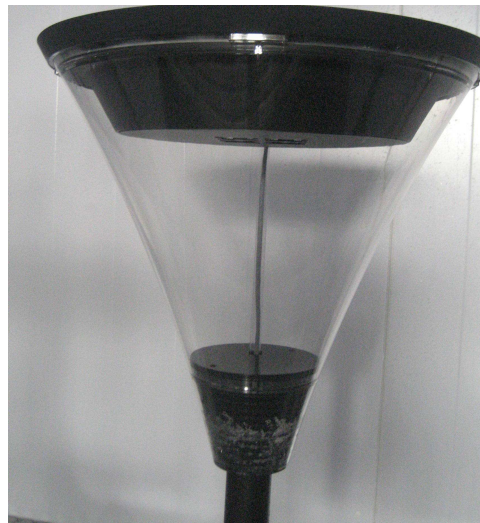
c) no trace of water on current-carrying parts or SELV parts or where it could become a hazard		N/A
	d) i) For luminaires without drain holes – no water entry	Test IPX6: After the test no found the water inside the luminaire. (see Annex 1)	P

Photograph No. 8 Luminaire after IPX6 test (Pass no found water into luminaire)

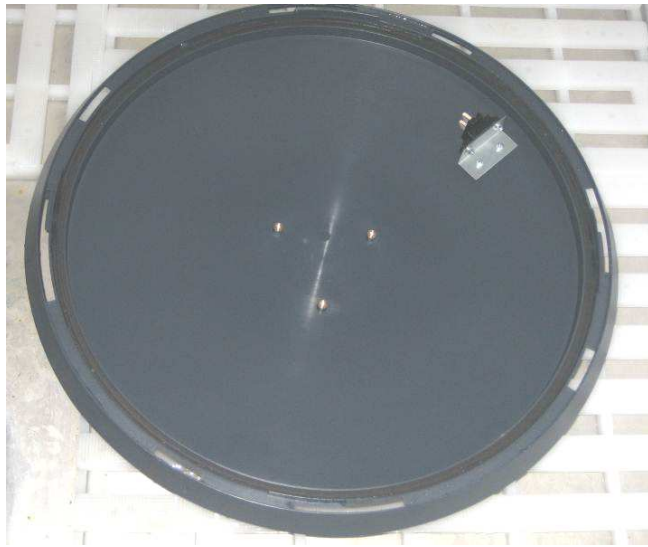
Photograph No. 9 Luminaire after IPX6 test (Pass no found water into luminaire)

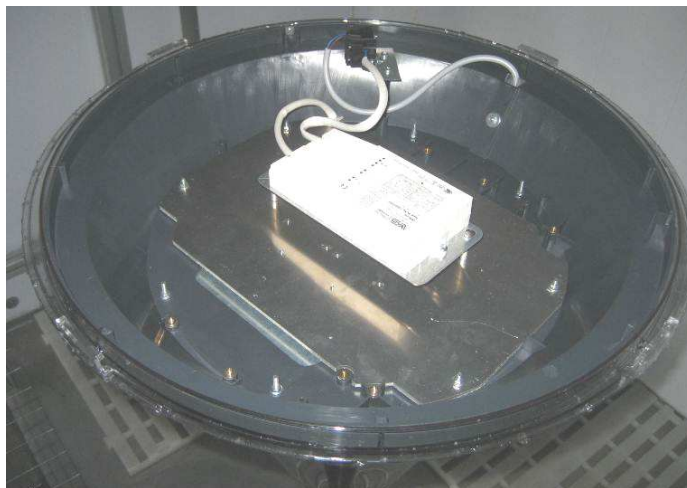
Photograph No. 10 Luminaire after IPX6 test (Pass no found water into luminaire)

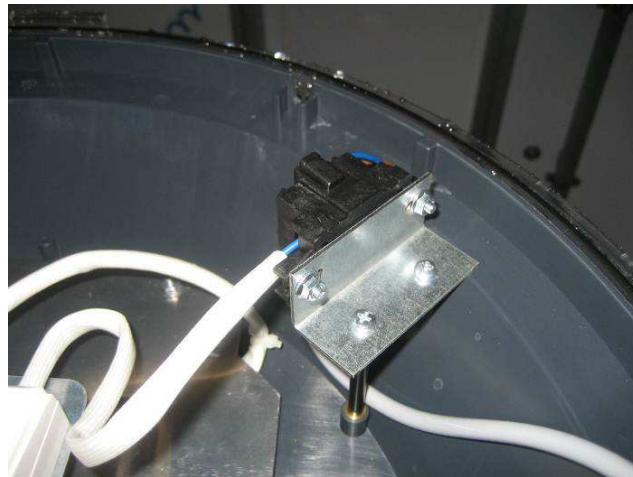
Photograph No. 11 Luminaire after IPX6 test (Pass no found water into luminaire)

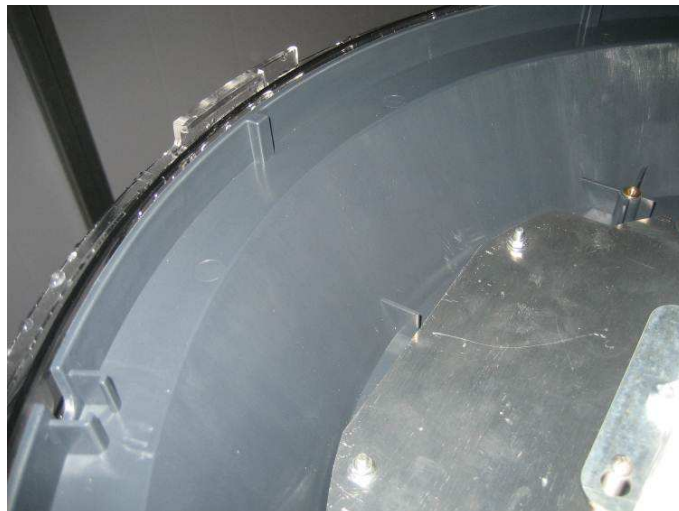
Photograph No. 12 Luminaire after IPX6 test (Pass no found water into luminaire)

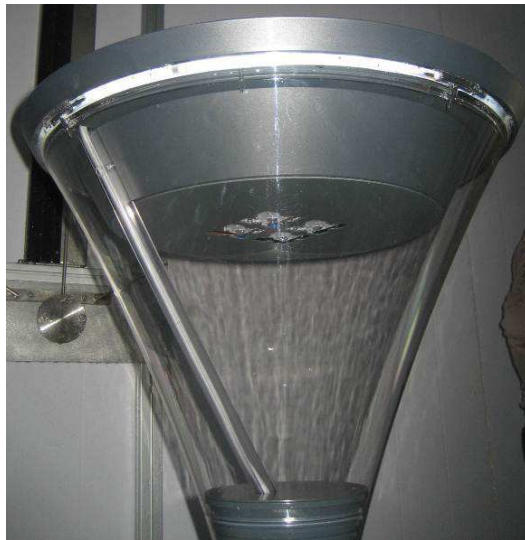
Photograph No. 13 Luminaire after IPX6 test (Pass no found water into luminaire)
